SITE NUMBER: B-R8-04
LOCAL NAME: Bogachiel Pit Pond
WRIA: 20.0248D

NORTH COAST OFF CHANNEL SITE INVENTORY DATA

RIVER SYSTEM: Bogachiel **DATE:** 8/3/89 **OBSERVER:** Young

CHANNEL TYPE: A large gravel pit pond and its egress channel.

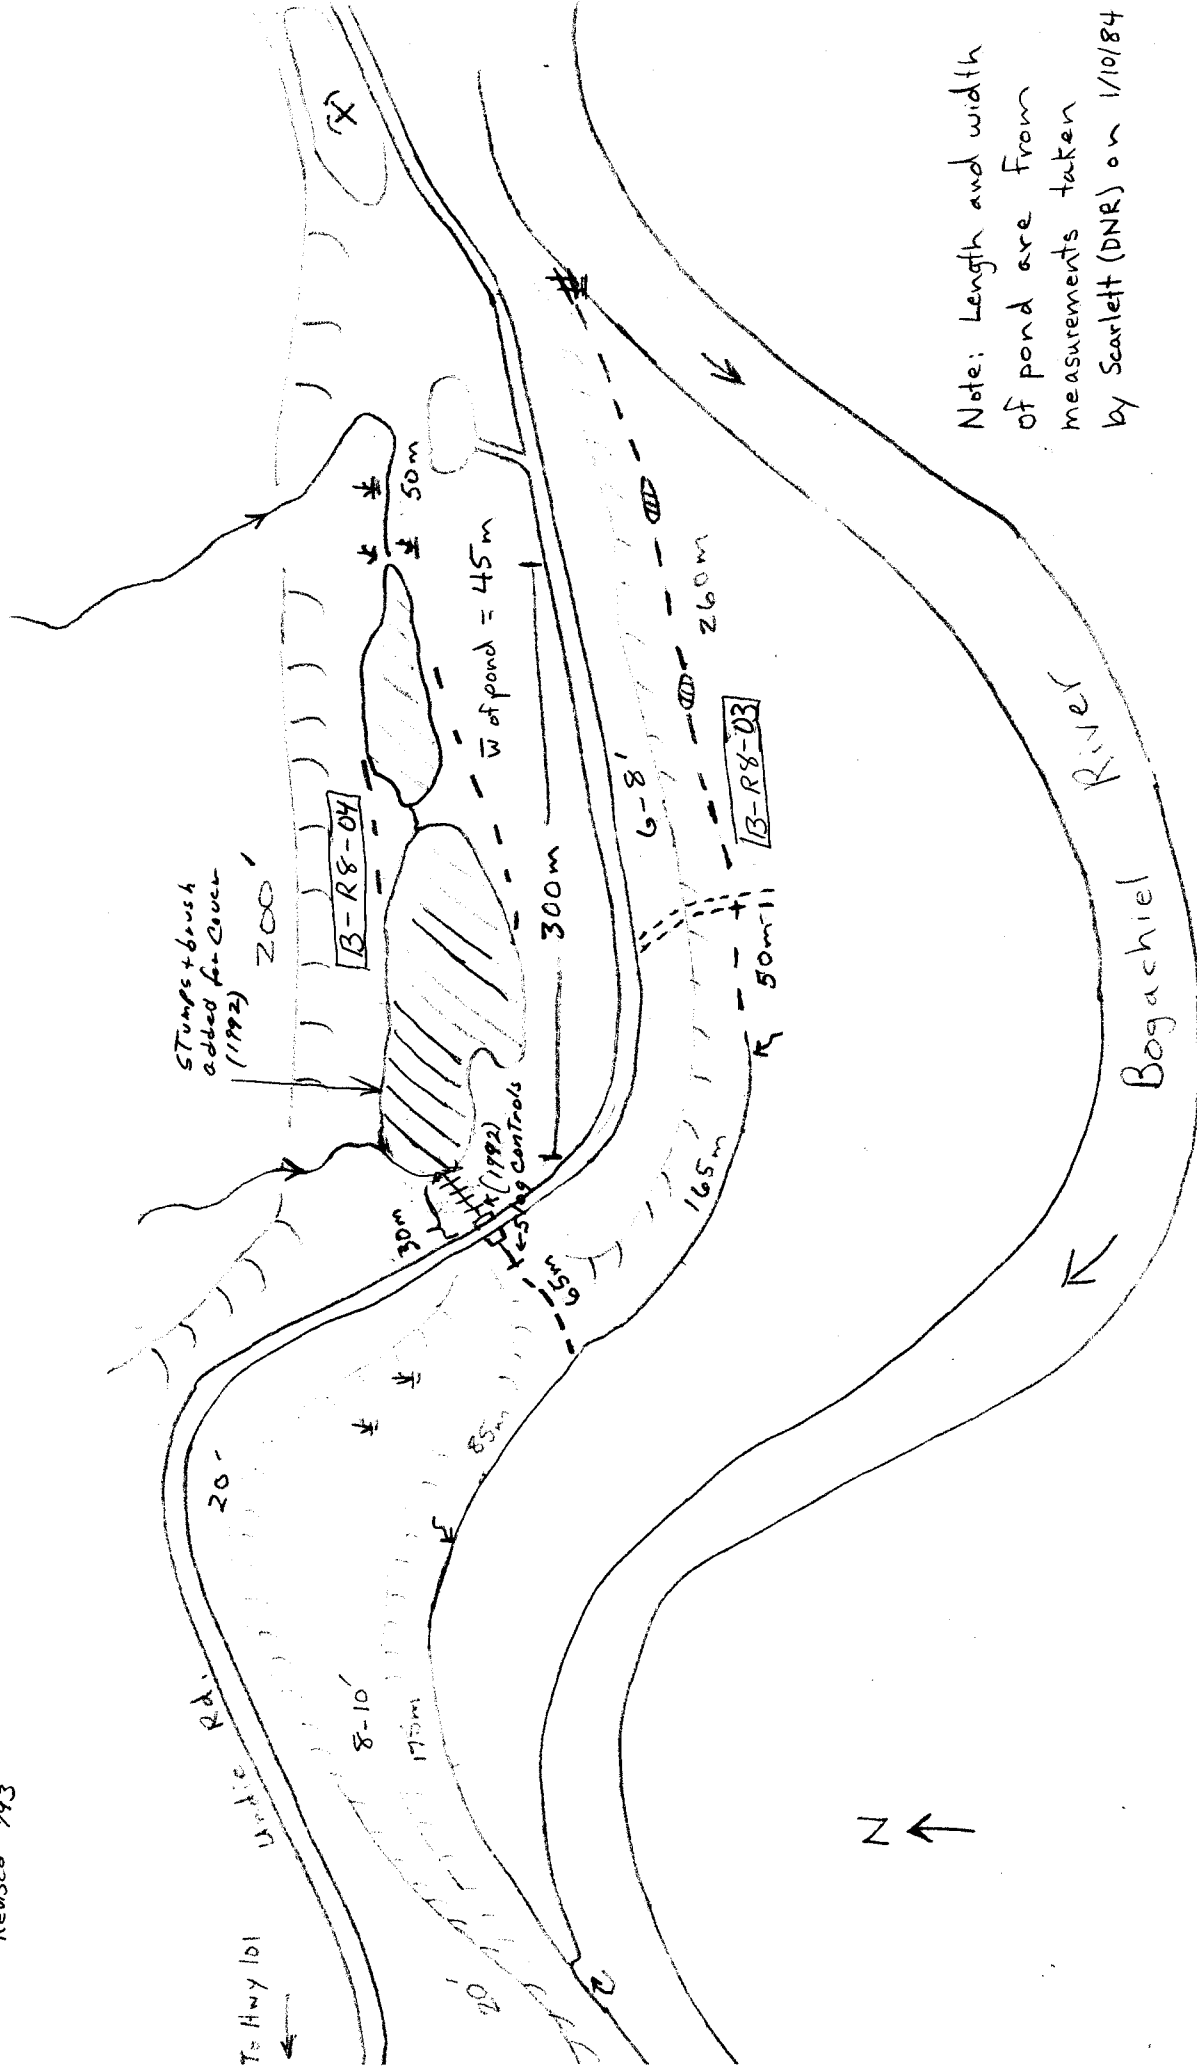
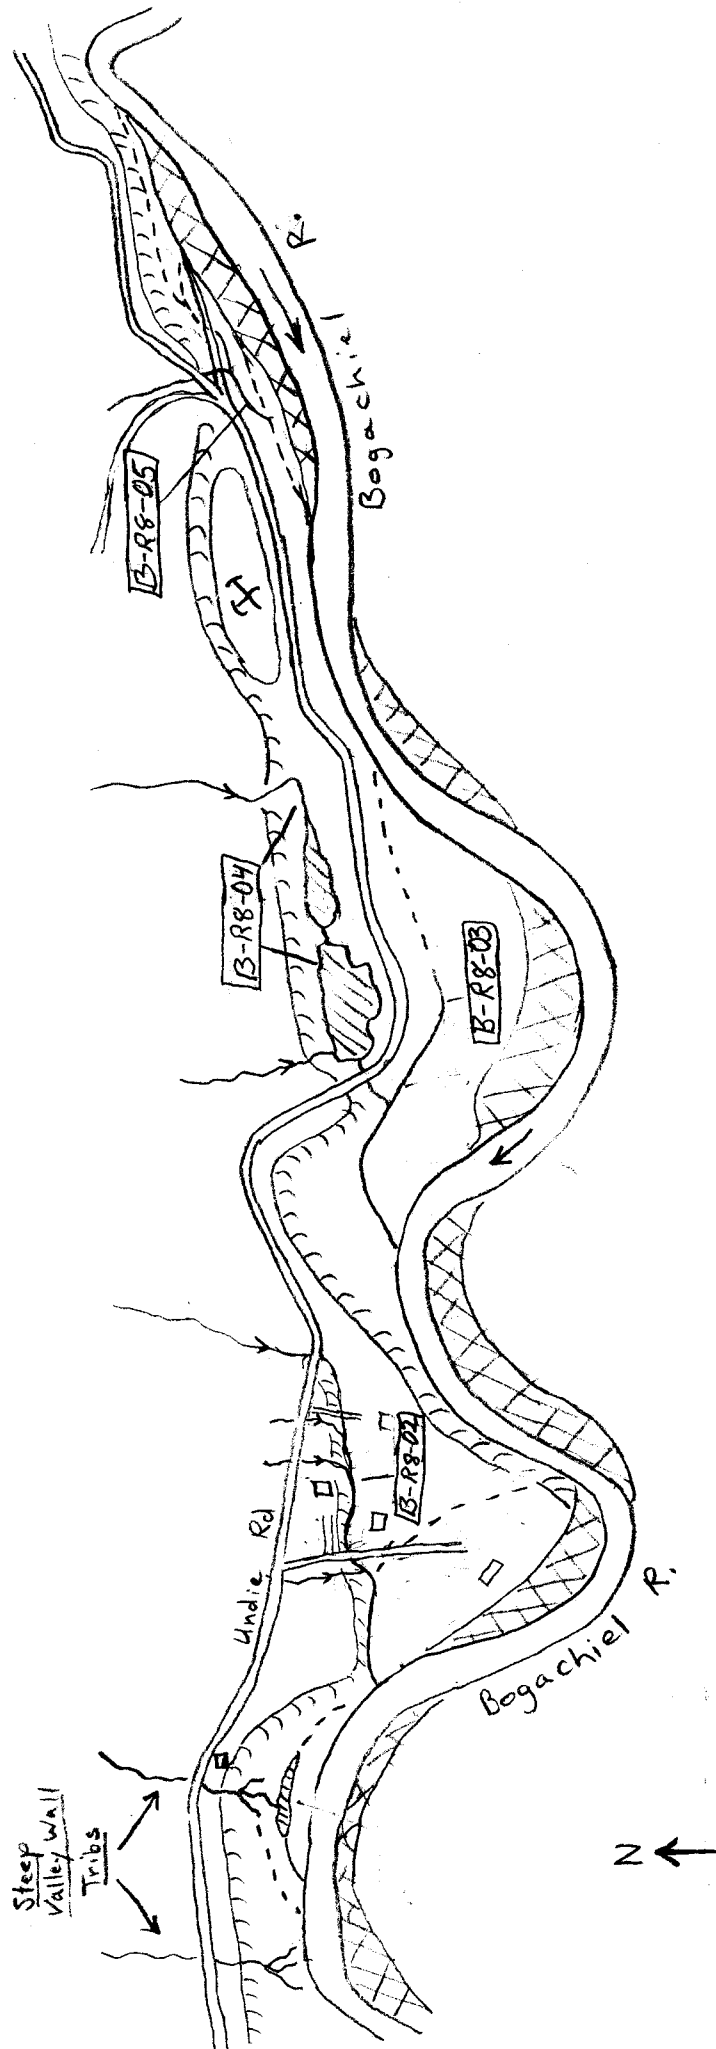
Bogachiel River
 AREA: B-R8
 SITE: B-R8-03 + B-R8-04
 TUCKER Pt Pond

Note: Length and width of pond are from measurements taken by Scarlett (DNR) on 1/10/84
